Geotechnical and Coring Services

# Old Cranston Road EMS Facility

## Morehead, Kentucky

CSI Project Number LX200044

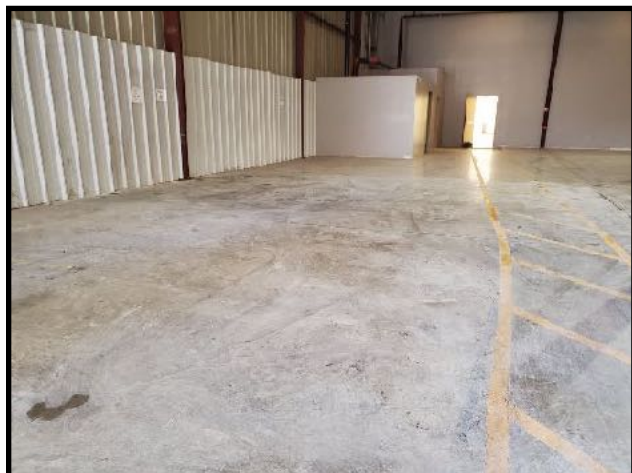
Photo 1. View of project area

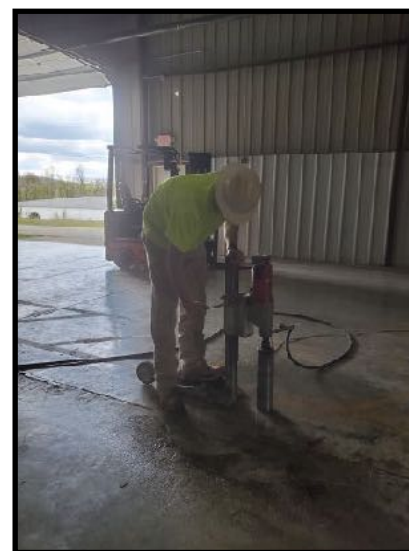
Photo 2. View of concrete coring

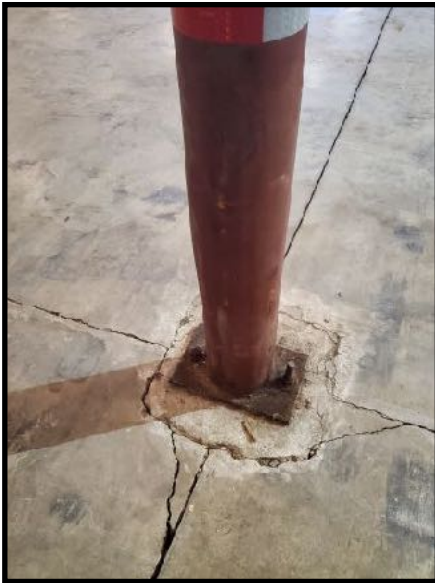
As previously mentioned, the proposed new EMS Facility will be located inside the existing site building. In general, the existing concrete floor slab appeared to be in good condition. Some minor cracking was observed around several of the existing interior columns. Additionally, a crack was observed in the slab along the eastern portion of the existing building.

Photo 3. View of cracking around interior column

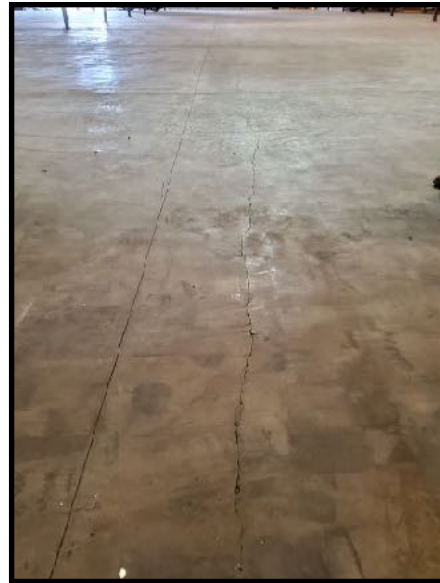
Photo 4. View of building addition area (facing west)

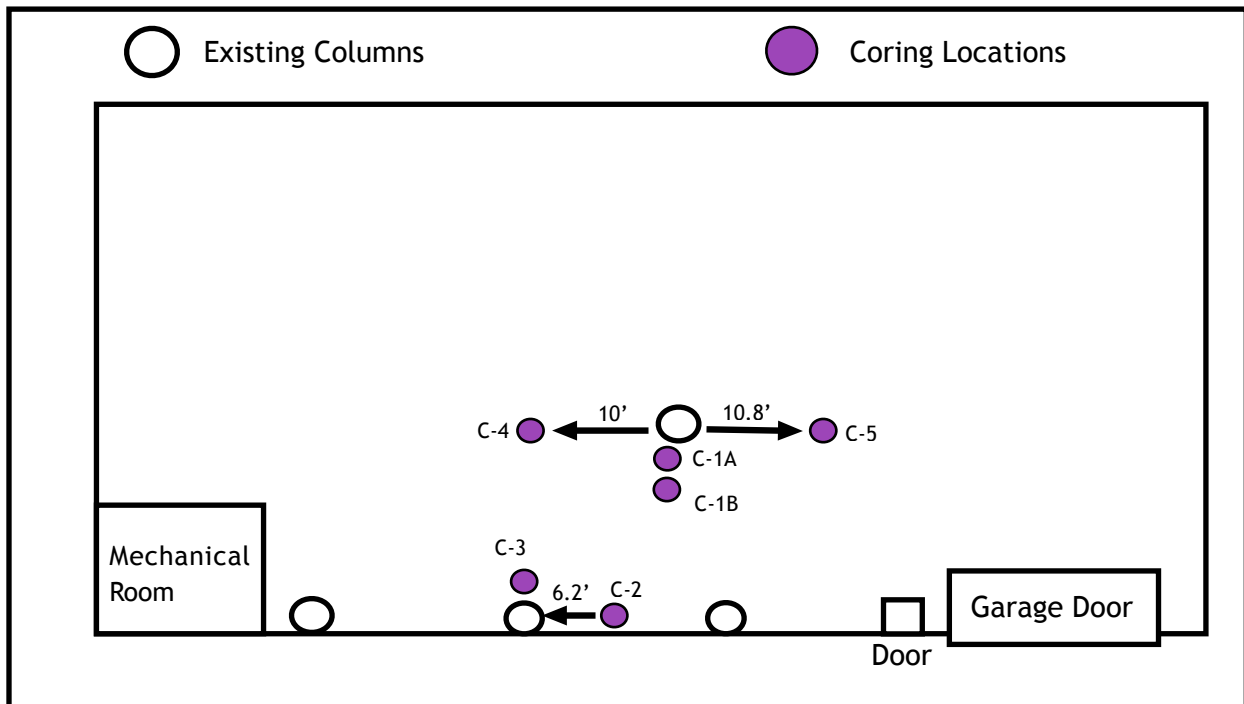
Figure 1. Approximate Boring Locations

We cored through the concrete slab in 6 locations within the footprint of the new EMS Facility (as shown in Figure 1). Hand augering and Dynamic Cone Penetrometer tests (DCPs) were performed (where applicable).

Boring C-1A was located 6 inches from an existing interior column. Hand auger refusal was encountered at a depth of 8 inches on a smooth continuous surface. An offset boring (C-1B) was performed 18 inches from the same existing column. Hand auger refusal was encountered at a depth of 8 inches on a rock fragment. A probe rod was then pushed on the side of the rock fragment and encountered refusal at a depth of 2 feet.

C-1A and C-1B were at an interior column and C-1A was drilled approximately 6 inches from the steel column. That boring encountered what we believe to be the top of a column footing at 8 inches deep. C-1B was drilled 12 inches further away from the column and did not encounter the footing top. Therefore, the column footing is likely to be a 2' x 2' (or similar sized) column footing.

At C-2 and C-3 locations (mid-span exterior columns and at a column, respectively), no footing was observed down to at least 2.6 and 2.7 feet. These were drilled approximately 6 inches from the existing wall, leading us to believe that either an 18-inch wide or narrower footing is in place or only a grade beam is below the wall (or combinations of both). Also, at C-3, the slab was almost 2 inches thicker than at other locations. This may indicate a “thickened slab” footing along the perimeter.

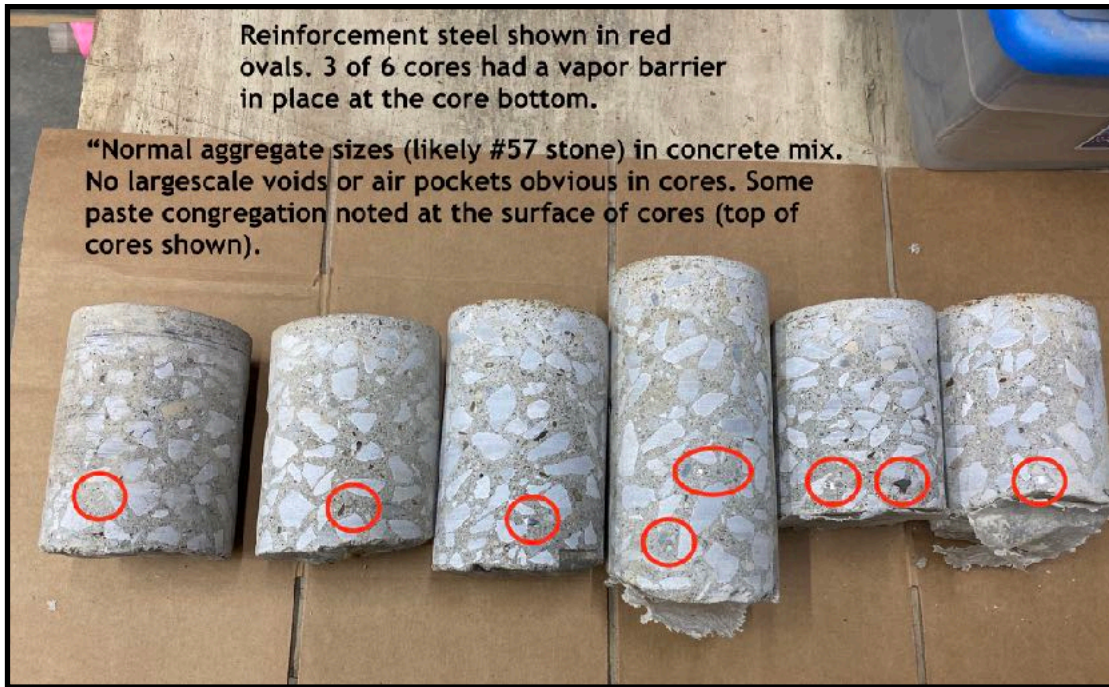
The slab thickness was generally about 5 inches. At core location C-3, the slab was significantly thicker and was possibly part of a “thickened slab” footing. All core locations had slab reinforcement, generally located within 1 inch of the slab bottom and appeared to be WWF reinforcement of about 0.15 to 0.24 inches in diameter (corresponding to about 1.4 to 4.5 wire size range for WWF). The slab concrete mix appeared to be somewhat normal in appearance compared to similar light duty warehouse slabs. No obvious large-scale air pockets were observed in the cores and the concrete mix contained #57 sized coarse aggregate. The top of the slab appeared to have some paste “congregation”, which is sometimes indicative a overfinishing (too much trowel or floating) the surface. See the photo on the following page for the recovered cores including highlighting the steel reinforcement.
