Addendum No. 1
Bid Date: October 8, 2020
to the
Plans, Specifications and Contract Documents
for
Columbia-Adair County Economic Development Authority
Contract 2: Green River Commerce Park -
Access Road Extension Grading and Drainage
Columbia, Kentucky

Report of Geotechnical Exploration

Green River Commerce Park - Access Road

CSI Project Number LX190143

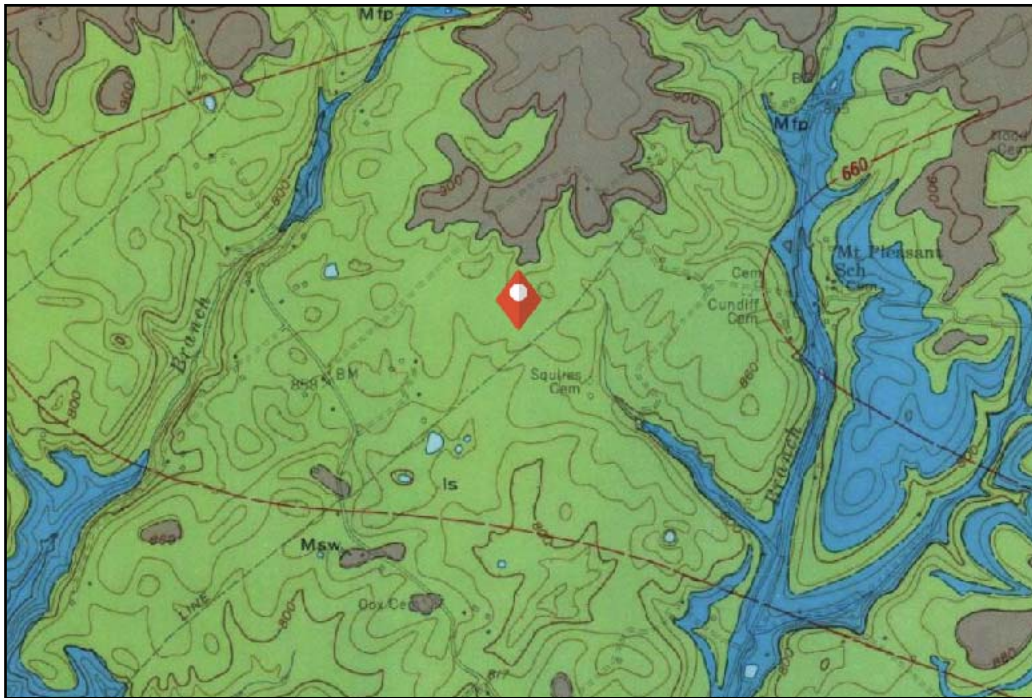
The claystone is described as greenish gray. The upper portions may contain few small lenses of calcareous shale, limestone, and sandstone. The clay stone is typically fine grained, and evenly bedded. *Figure 2* depicts the site geology of the project area.

Figure 2. Site Geology USGS Geologic Map of the Cane Valley Quadrangle, dated 1964 (site vicinity indicated by marker)

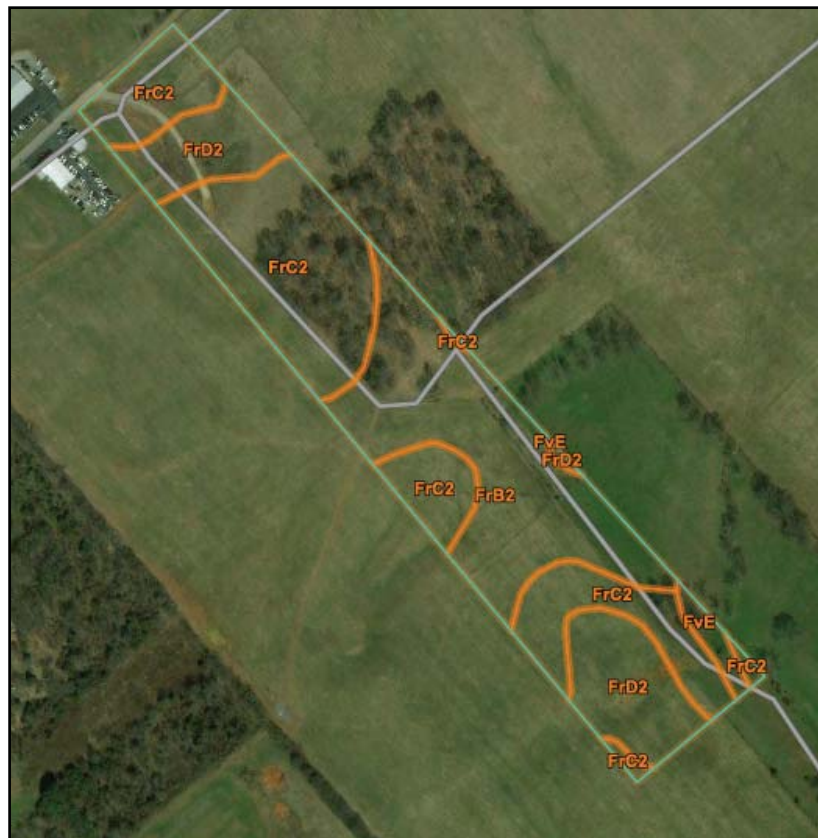
Due to the development of the site vicinity, the soil survey information listed above may no longer be useful since the site soils may have been altered. Thus, the soils described above may be on-site but not in their natural condition. *Figure 3* is the soils map from the USDA website.

Figure 4: USDA Soil Survey Map of Project Site (site bordered in green and orange)

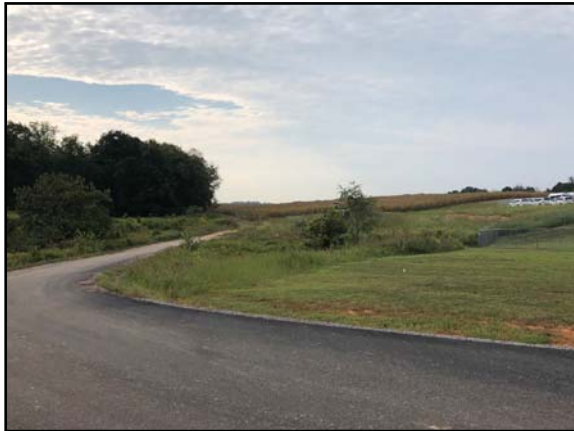
Photo 1. View of the north side of the site with the existing asphalt paved road and surface depression (facing southeast)

As mentioned in our karst research section, a depression is located on the north side of the project site near the end of the asphalt paved roadway that ends shortly after entering the site. The bottom of the depression consisted of tall weeds and thick brush with few trees. No other obvious depressions were observed on the project site. Please note, the majority of the site's surface is covered by tall grasses and corn crops. Thus, obvious signs of surface depressions were difficult to observe during our site visit.

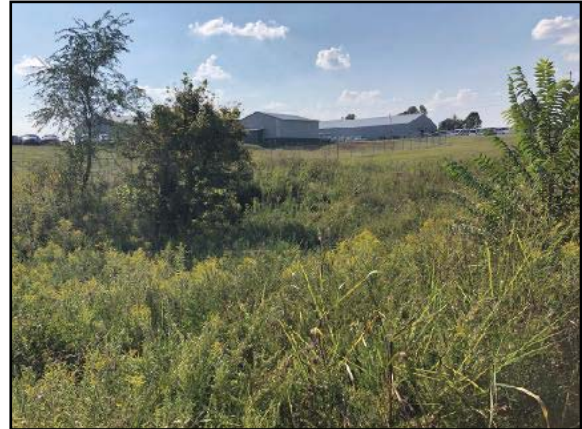
Photo 6. View of the surface depression with the bottom covered with grass and few trees

The site is located in an area with high potential for karst development. KGS mapping indicated a sinkhole located on the north side of the project site as well as on surrounding properties. Refer to *Figure 3* for more details. While on-site, CSI observed a depression that is located on the north side of the project site near the end of the asphalt paved roadway that ends shortly after entering the site. The bottom of the depression consisted of tall weeds and thick brush with few trees.

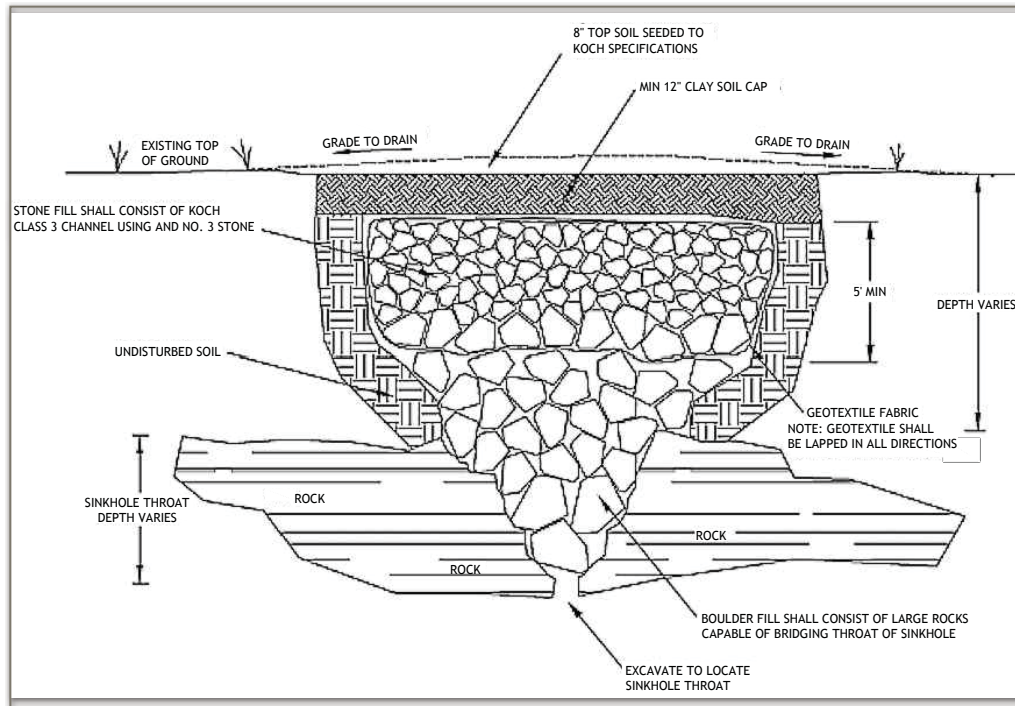
Once the Karst feature has been excavated to the satisfaction of the CSI geotechnical engineer, heavy-duty, non-woven filter fabric is used to line the excavation. The filter fabric allows water to flow through the rock within the filter, but will not allow soil fines to be washed away. Large rock is then placed in the bottom of the excavation. The size of the large rock fragments will depend entirely upon the size and depth of the excavation. It is imperative that the size of rock fragments used in the bottom layer be considerably larger than the solution channel opening in the bedrock. Thus, large rock boulders would be used for a large excavation, while rip rap would be used for a smaller excavation. Layers of smaller rock fragments would then be placed on top of the larger rock fragments until the desired grade is obtained. For large/deep excavations, the rock fragments would typically consist of layers of boulders, rip rap, No. 2 stone, capped with No. 57 stone. For smaller/shallow excavations, the rock fragments would typically consist of layers of No. 2 stone capped with No. 57 stone. The thickness of each layer of rock should be determined in the field by the CSI geotechnical engineer.

Once the final layer of No. 57 crushed stone is placed, it should be leveled by raking. Once leveled, the filter fabric should be lapped over the No. 57 crushed stone so that no stone is exposed. The filter fabric should totally encapsulate the rock filter with no gaps between pieces of filter fabric. A minimum overlap of 2 feet is typically recommended for filter fabric used in inverted rock filters. From this elevation, compacted soil or crushed stone can be used to obtain the desired final grade. Please reference the the following diagram.

Figure 9: Example of Inverted Rock Filter Cross Section (For Reference Only)

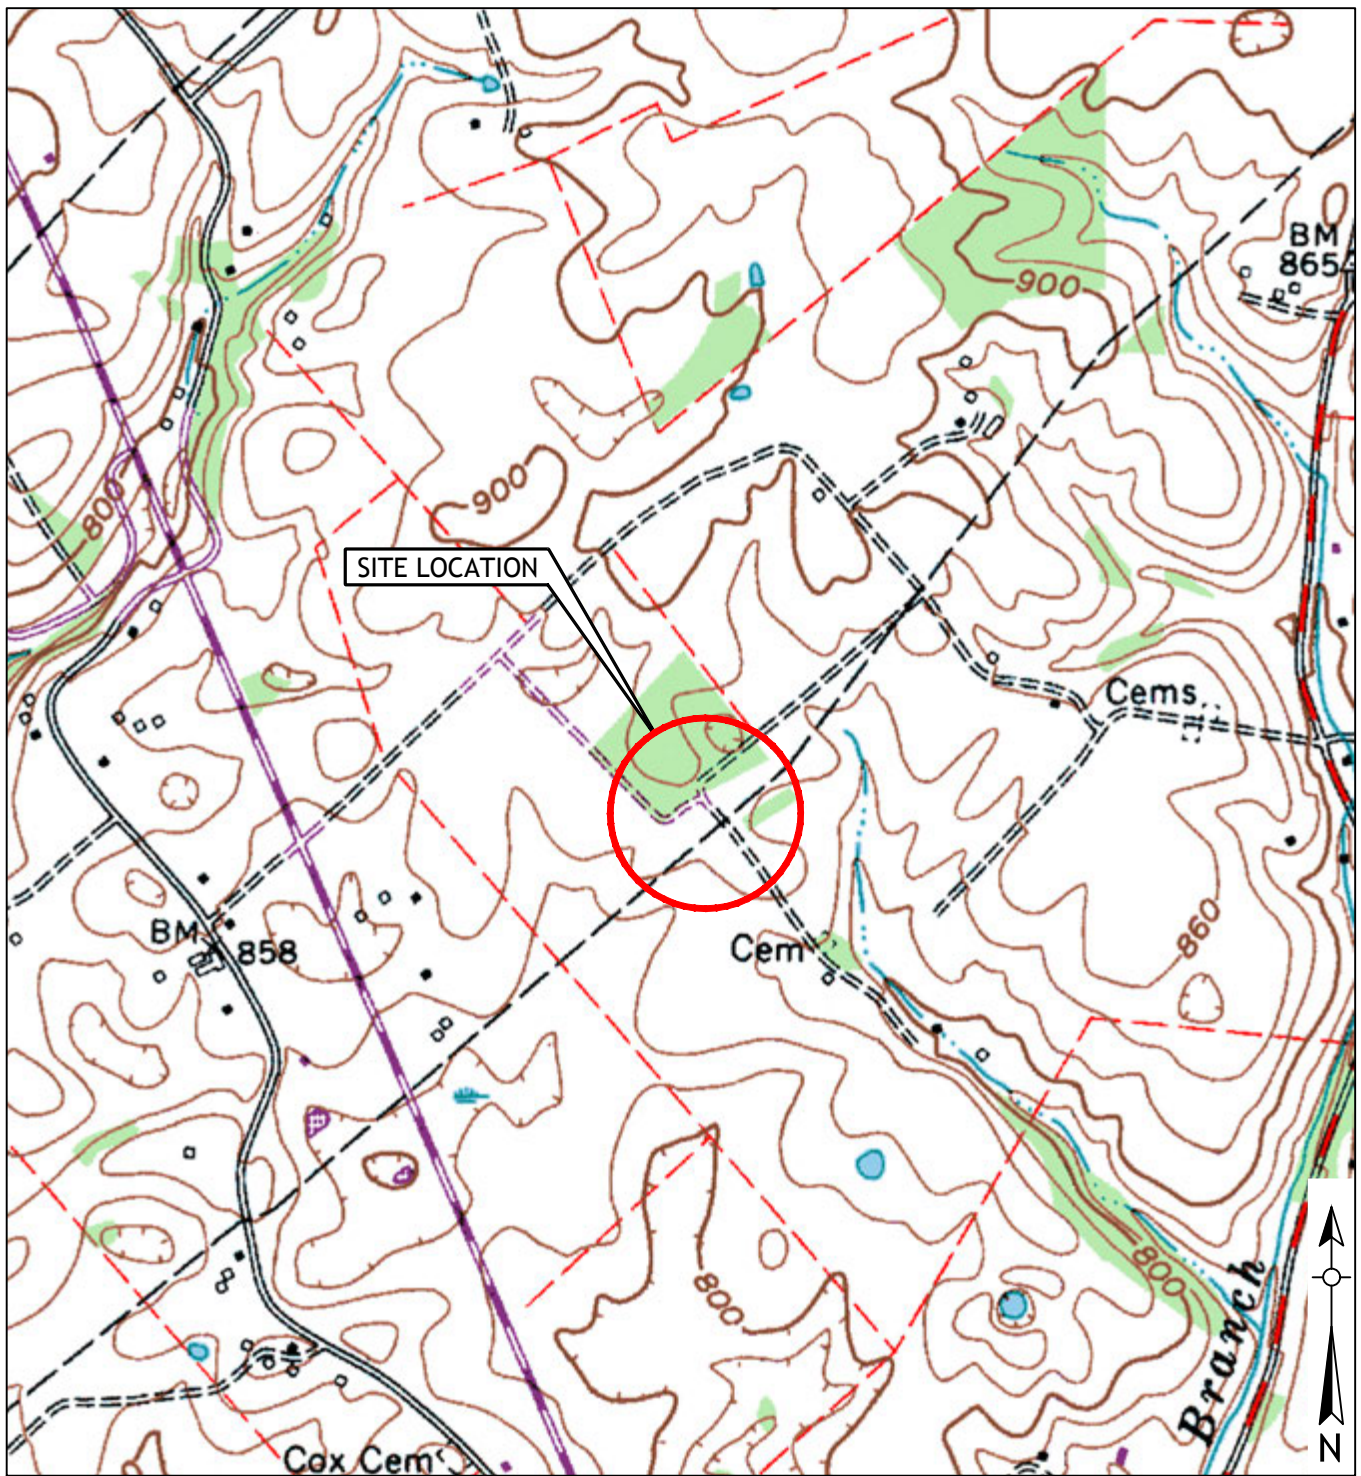
Site Location Plan adapted from USGS Cane Valley, Kentucky Topographic Quadrangle map dated 1979, with further adaptation by CSI personnel.
